Geography 309: Research Methods in Geography
Due: Wednesday 20th October

Final Group Report:

Stormwater Management in rural Lyttelton Harbour.

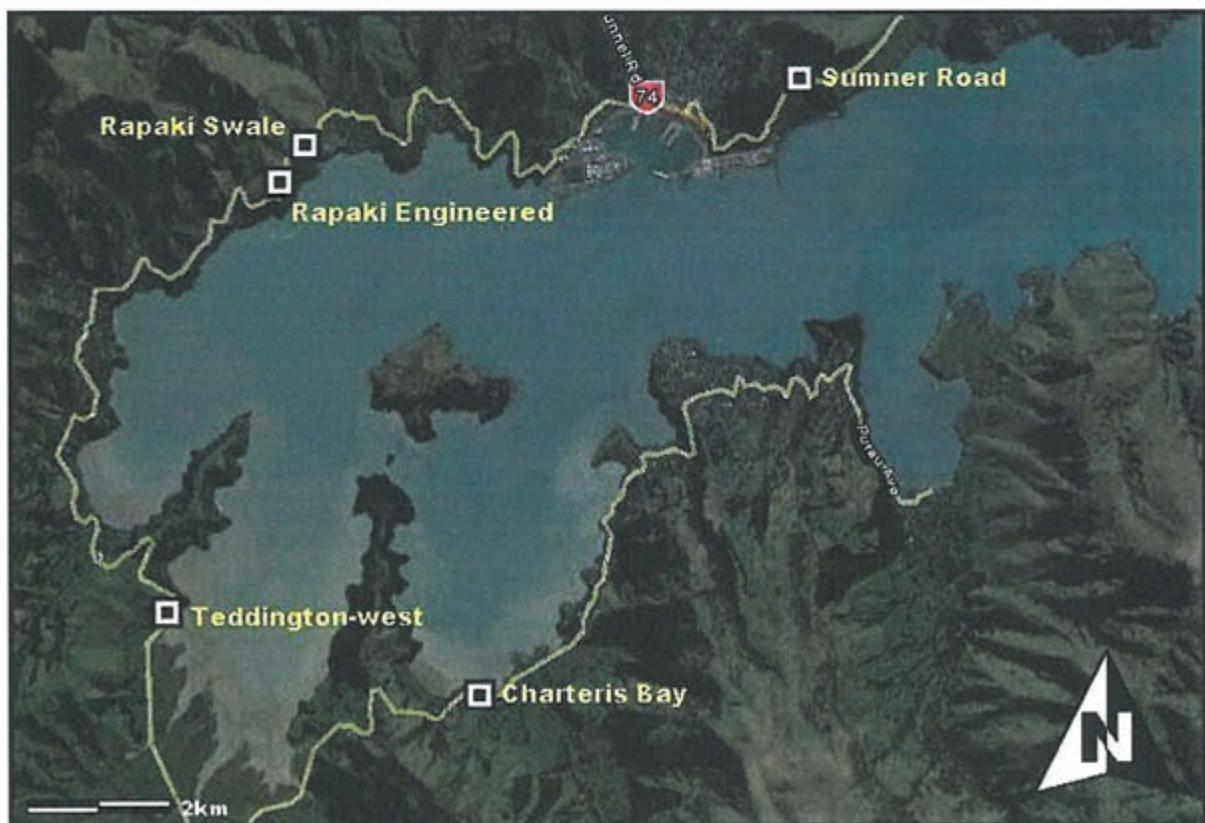
Figure 1: Map of study area. The engineered sites are: Rapaki Engineered and Sumner Road. The non-engineered sites are Rapaki Swale, Teddington-west and Charteris Bay.
Image retrieved and modified from Google earth on the 16/10/2010.

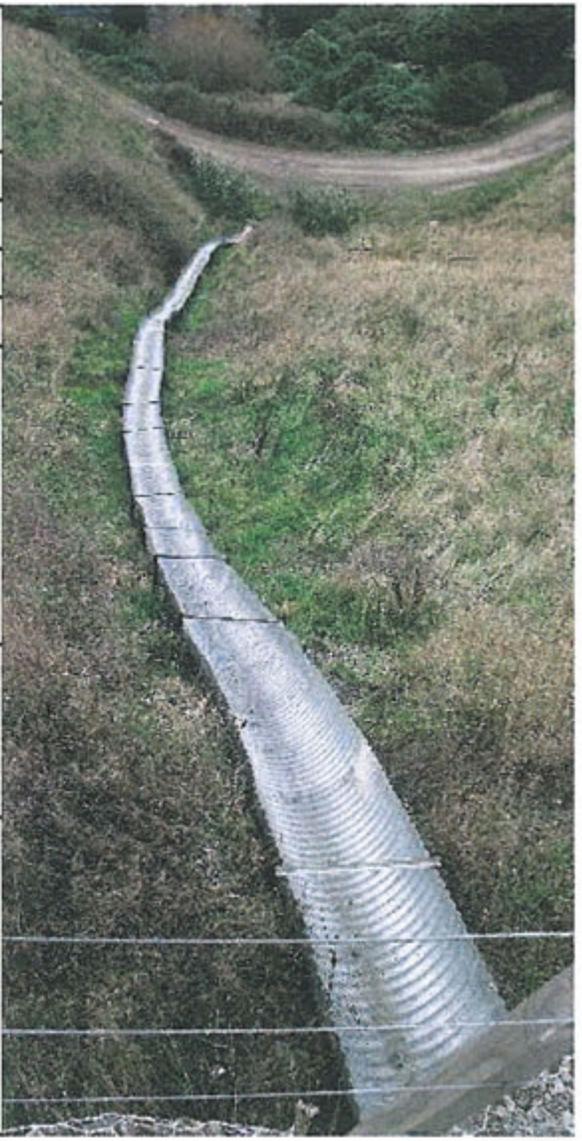
Site	Sumner Road Lat;43°36'01.51"S Long;172°44'08.48"E			
Location	Sumner Road above port coal store			
System	Sediment trap + Conduit		Sediment Concentration (gm/L)	
Drainage Length (m)	120	Flow Regime	Top	Bottom
Culvert Diameter (mm)	TBA	Low Flow	0.0025	0.0028
Height of outlet (mm)	TBA	Mid Flow	0.0059	0.0045
Gradient of outflow	TBA	High Flow	0.031	0.016
Source Environment

Long section of asphalt roading. Hillside upslope of road is near vertical, exposed mixed quality igneous. Unlikely to yeild great volumes of entrainable sediments. Sediment trap is likely to effectively remove bedload sediments and larger clasts.

An overland conduit follows a steep valley gradient. A flow exists under the conduit (leakage or baseflow)

Little or no erosion is present where flow exists beneath the conduit despite steepness and apparent constraint of channel banks. Lush, long grass, lines this flow path.

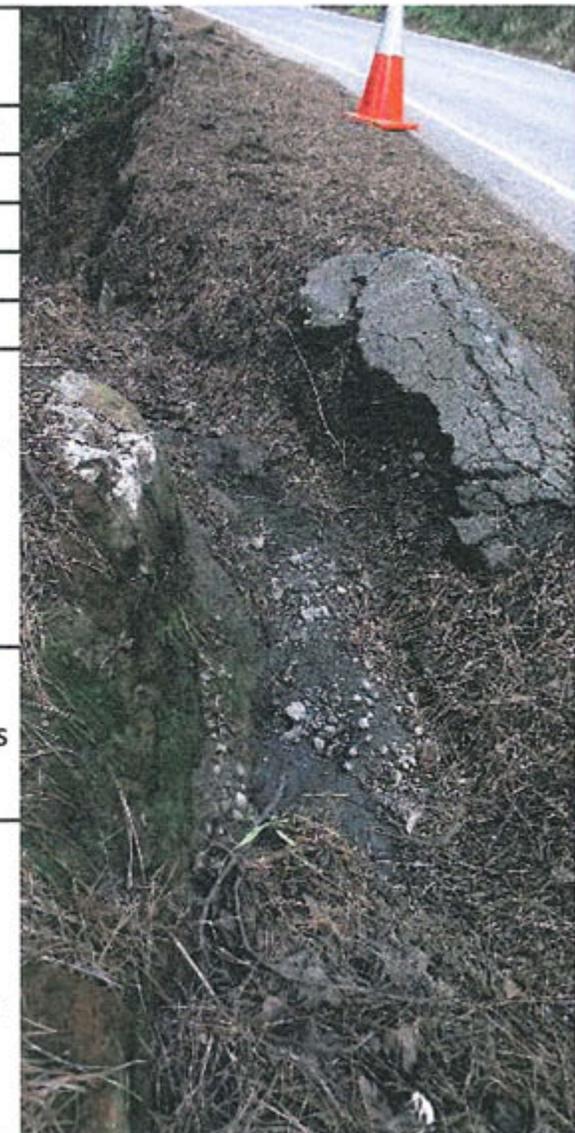
Site	Old Quarry Lat;43°36'01.51"S Long;172°44'08.48"E			
Location	On Sumner Road, opposite road to Timeball			
System	Uncontrolled		Sediment Concentration (gm/L)	
Drainage Length (m)	80	Flow regime	Top	Bottom
Culvert Diameter (mm)	No culvert	Low Flow	No Data	
Height of outlet (mm)		Mid Flow	No Data	
Gradient of outflow	>45°	High Flow	0.19	
Source Environment

Source environment is a small drainage trough between a section of anticamber on Sumner Road and an unpaved layby on the port side of the road. Low gradient and small area, however stormwater over this catchment is clearly incising a channel and flow is eroding where it leaves the roadside.

Stormwater here discharges to LPC reclaimed land, this is a large flat area where infiltration is possible.

Rivulet descends through bramble and surface mat vegetation. The area is overarched by a canopy of large wilding pines. This discharge slope appears to be in static equilibrium for the time being but it is steep and may remobilise under extreme conditions.

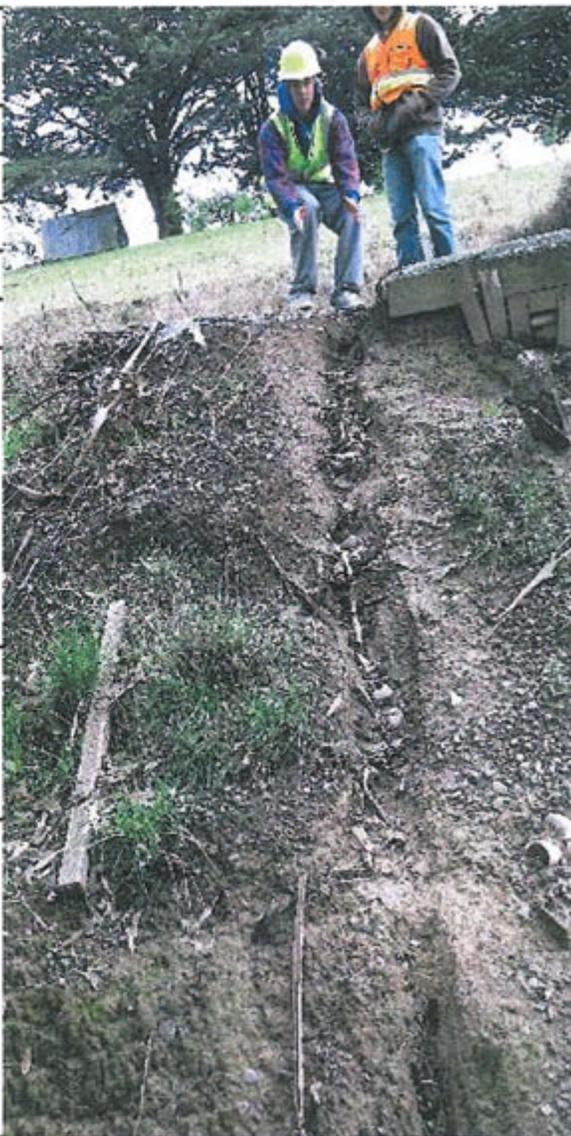
Site	Cass bay Lat;43°36'01.51"S Long;172°44'08.48"E			
Location	West side of Cass bay above gabion reinforcing			
System	Uncontrolled		Sediment Concentration (gm/L)	
Drainage Length (m)	60	Flow regime	Top	Bottom
Culvert Diameter (mm)	No Culvert	Low Flow	No Data	
Height of outlet (mm)	N/A	Mid Flow	No Data	
Gradient of outflow	30°	High Flow	No Data	
Source Environment

Very similar to Old Quarry. Run-off occurs over a small section of sealed road where the camber leads flow away from the inside gutter. This flow though usually very small has found passage over the road edge where it is eroding the bank. There is little or no source environment for sediments to become entrained in stormwater.

Outflow Environment				
	Gum tree plantation. Little to no ground cover vegetation, exposed loess slope

Lower Catchment				
	Rill erosion is taking place directly down slope. There appears to be ample space for suspended sediments to settle out and accumulate before reaching the harbour waters.

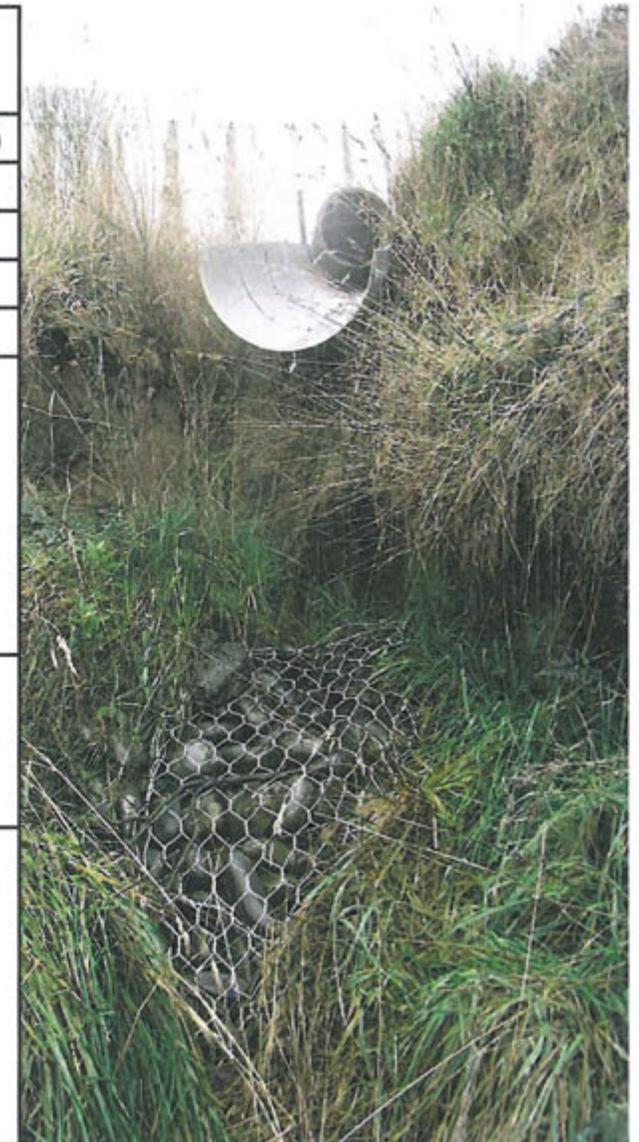
Site	Rapaki engineered Lat;43°36'01.51"S Long;172°44'08.48"E			
Location	West of Rapaki on Lyttelton, Governors Bay Road			
System	Series filters, discharge to gabion		Sediment Concentration (gm/L)	
Drainage Length (m)	252	Flow Regime	Top	Bottom
Culvert Diameter (mm)	465	Low Flow		0.076
Height of outlet (mm)	1115	Mid Flow	0.22	0.17
Gradient of outflow	22°	High Flow	2.17	1.42
Source Environment	<p>Long section of roadside ditch guttering. Several large bank cuttings.</p>			
Outflow Environment	<p>Culvert flows out of roadside retaining wall and falls onto a gabion basket 1.2m below. Moderate slope.</p>			
Lower Catchment	<p>Dense vegetation lines a natural drainage gully, there is little to suggest that major erosion is happening in this tributary however, splash and rill erosion is evident above and around the gabion basket.</p>

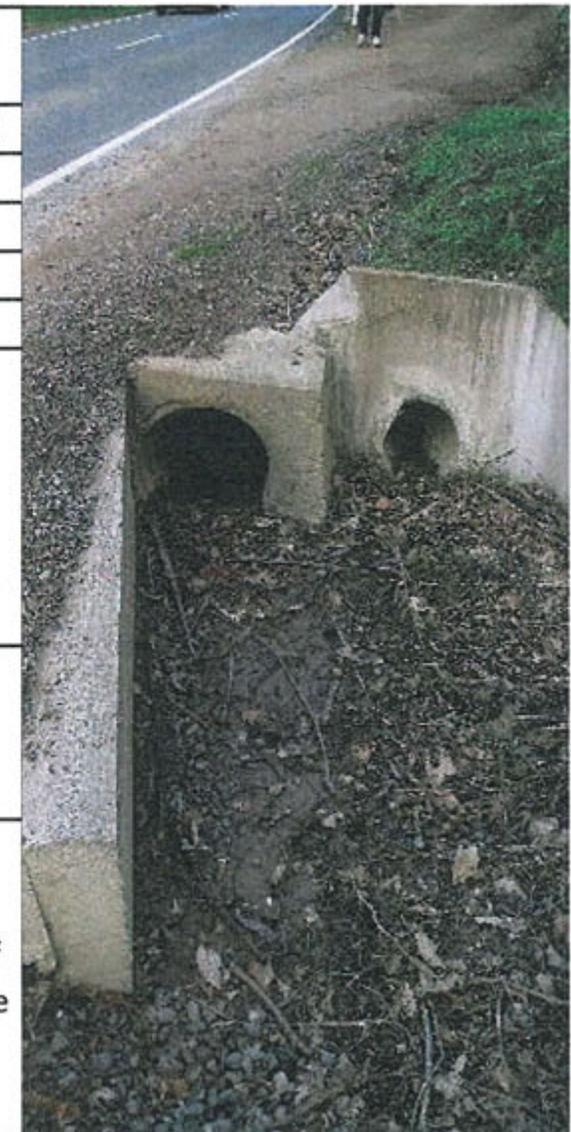
Site	Ohinetahi Lat;43°36'01.51"S Long;172°44'08.48"E			
Location	Ohinetahi, above broad unpaved carpark/ layby			
System	Debris grill, sump, twin culvert		Sediment Concentration (gm/L)	
Drainage Length (m)	220	Flow regime	Top	Bottom
Culvert Diameter (mm)	255 and 157	Low Flow	N/A	N/A
Height of outlet (mm)	0	Mid Flow	N/A	N/A
Gradient of outflow	5°	High Flow	N/A	N/A
Source Environment

This system appears to capture stormflow from two distinct catchment environments. A collapsing roadside cutting exists above a well vegetated gutter ditch which flows through tailings and a debris grill into a sump.

Outflow Environment	Tailings, low gradient unpaved carpark			
---------------------	--	--	--	--

Lower Catchment	The carpark here appears to be a suitable area for settling out of sediment and infiltration of stormwater. There is both room for run-off to fan and good apparent drainage material in the layby.			
-----------------	---	--	--	--

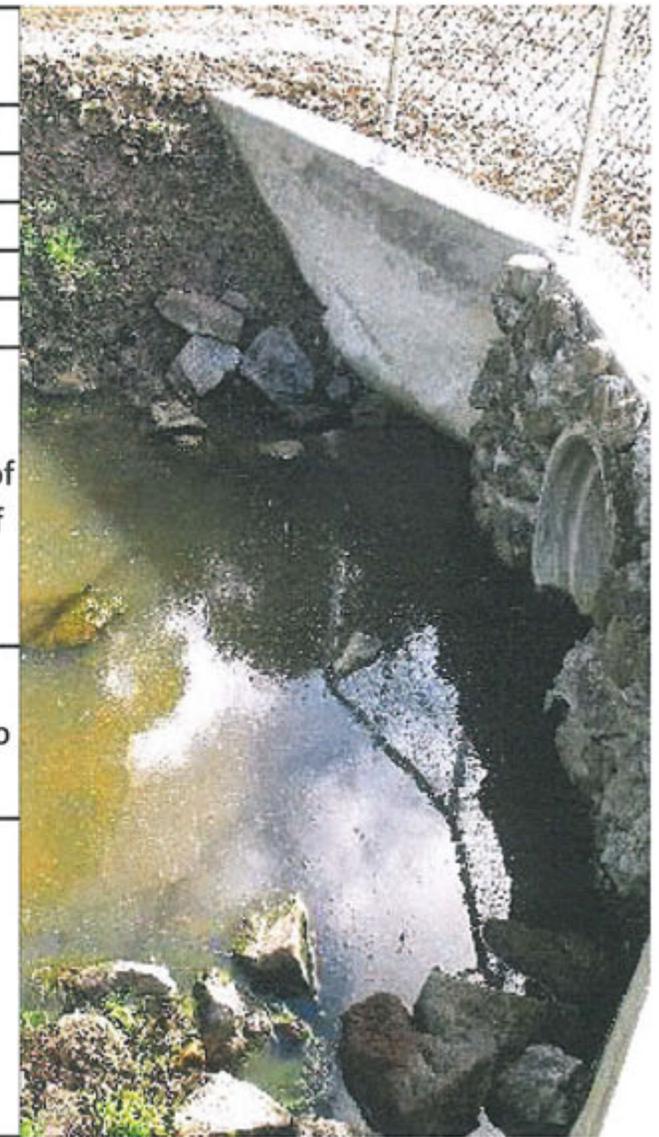
Site	Allandale Lat;43°36'01.51"S Long;172°44'08.48"E			
Location	Allandale (old dump site) tidal fringe			
System	Settling pond		Sediment Concentration (gm/L)	
Drainage Length (m)	260	Flow regime	Top	Bottom
Culvert Diameter (mm)	465	Low Flow	No Data	
Height of outlet (mm)	0	Mid Flow	0.012	0.0058
Gradient of outflow	0°	High Flow	0.14	
Source Environment

This settling pond receives waters from steep farmland and vegetated slopes. A long section of roadside guttering comes down into the bay area from the Ohinetahi watershed and some of this drainage is likely to be captured by the system.

Tidal flats. This system outflows directly into the harbour when water levels cause the pond to overflow.

Settling pond is the lower most feature of this catchment.

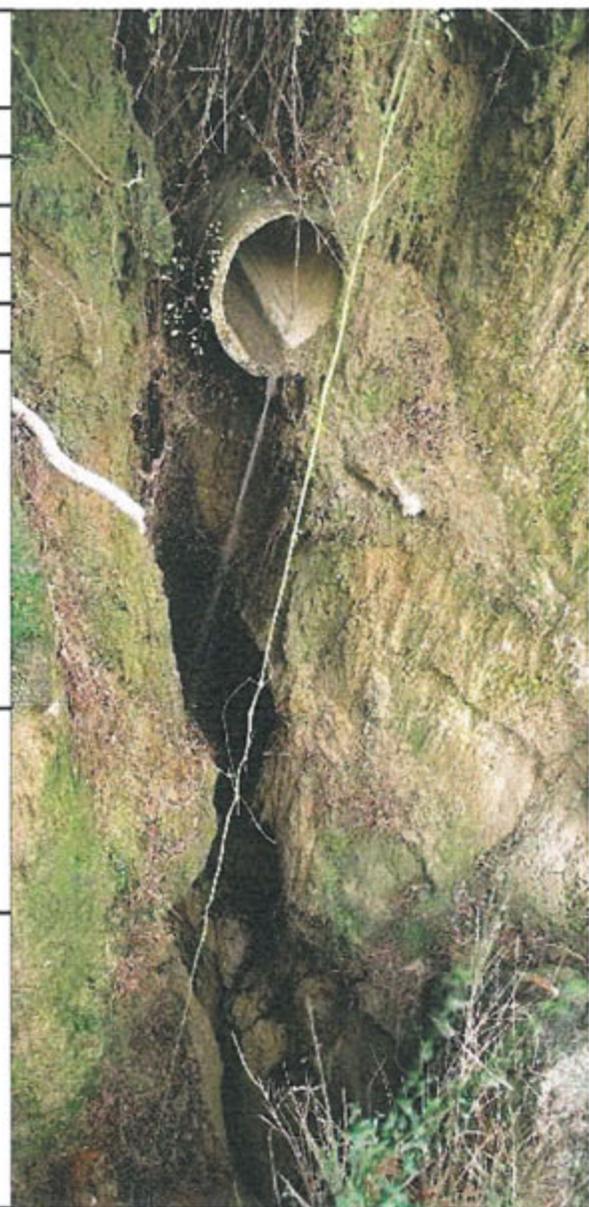
Site	Teddington-west Lat;43°36'01.51"S Long;172°44'08.48"E			
Location	West side of Teddington			
System	Culvert to slope		Sediment Concentration (gm/L)	
Drainage Length (m)	420*	Flow regime	Top	Bottom
Culvert Diameter (mm)	315	Low Flow	0.103	1.663
Height of outlet (mm)	1800-2600**	Mid Flow	4.81	4.96
Gradient of outflow	35°	High Flow	6.35	7.23
Source Environment	<p>A long section of roadside guttering. Collapsed bank cuttings periodically obstruct the watercourse. *Another drainage culvert 217 metres up the road is blocked and so this site services drainage for 420 metres of roading. ** High flows have trajectories that carry further downhill</p>			
Outflow Environment	<p>Extensive rilling erosion is undercutting and toppling trees in a small Macrocarpa plantation. This process appears to have displaced high volumes of the lower catchment.</p>			
Lower Catchment	<p>Sediment is accumulating over low gradients at the coastal fringe. The deposition fan is becoming colonised by scrubby vegetation and grass.</p>

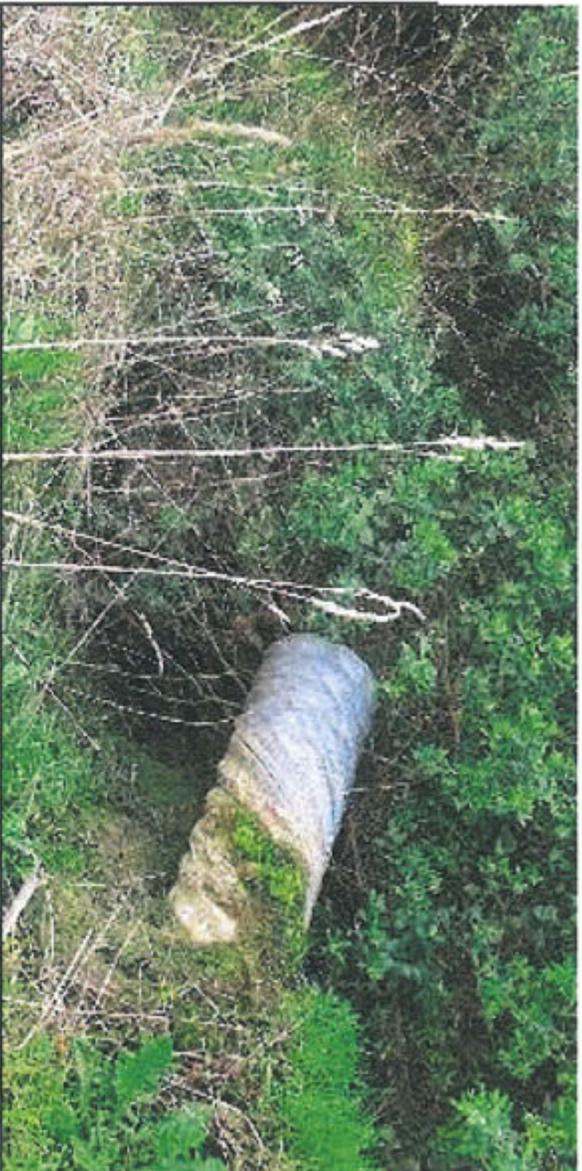
Site	Charteris Bay Lat;43°36'01.51"S Long;172°44'08.48"E			
Location	South end of Charteris Bay			
System	Culvert to slope		Sediment Concentration (gm/L)	
Drainage Length (m)	210	Flow Regime	Top	Bottom
Culvert Diameter (mm)	327	Low Flow	No Data	No Data
Height of outlet (mm)	780	Mid Flow	0.54	0.66
Gradient of outflow	46°	High Flow	2.62	5.12
Source Environment		<p>High and steep roadside cutting feeds loess sediments to ditch on inside bend of road. Hard surfaces also drain to inside bend. The outside of the bend is wide, vegetated and permeable, saturation levels in this area probably fluctuate daily and seasonally.</p>		
Outflow Environment		<p>Steep, uncontrolled and eroding. Scrubby vegetation, coarse unsorted amalgam of sediments.</p>		
Lower Catchment		<p>Water is culverted under road to steep vegetated bank directly to the tidal zone. Flow is scouring a deepening channel through coarse aggregate stones and mud.</p>
