Sediment Runoff from Roadside Cuttings in Lyttelton Harbour

Report for the Lyttelton Harbour Issues Group

15th October 2010

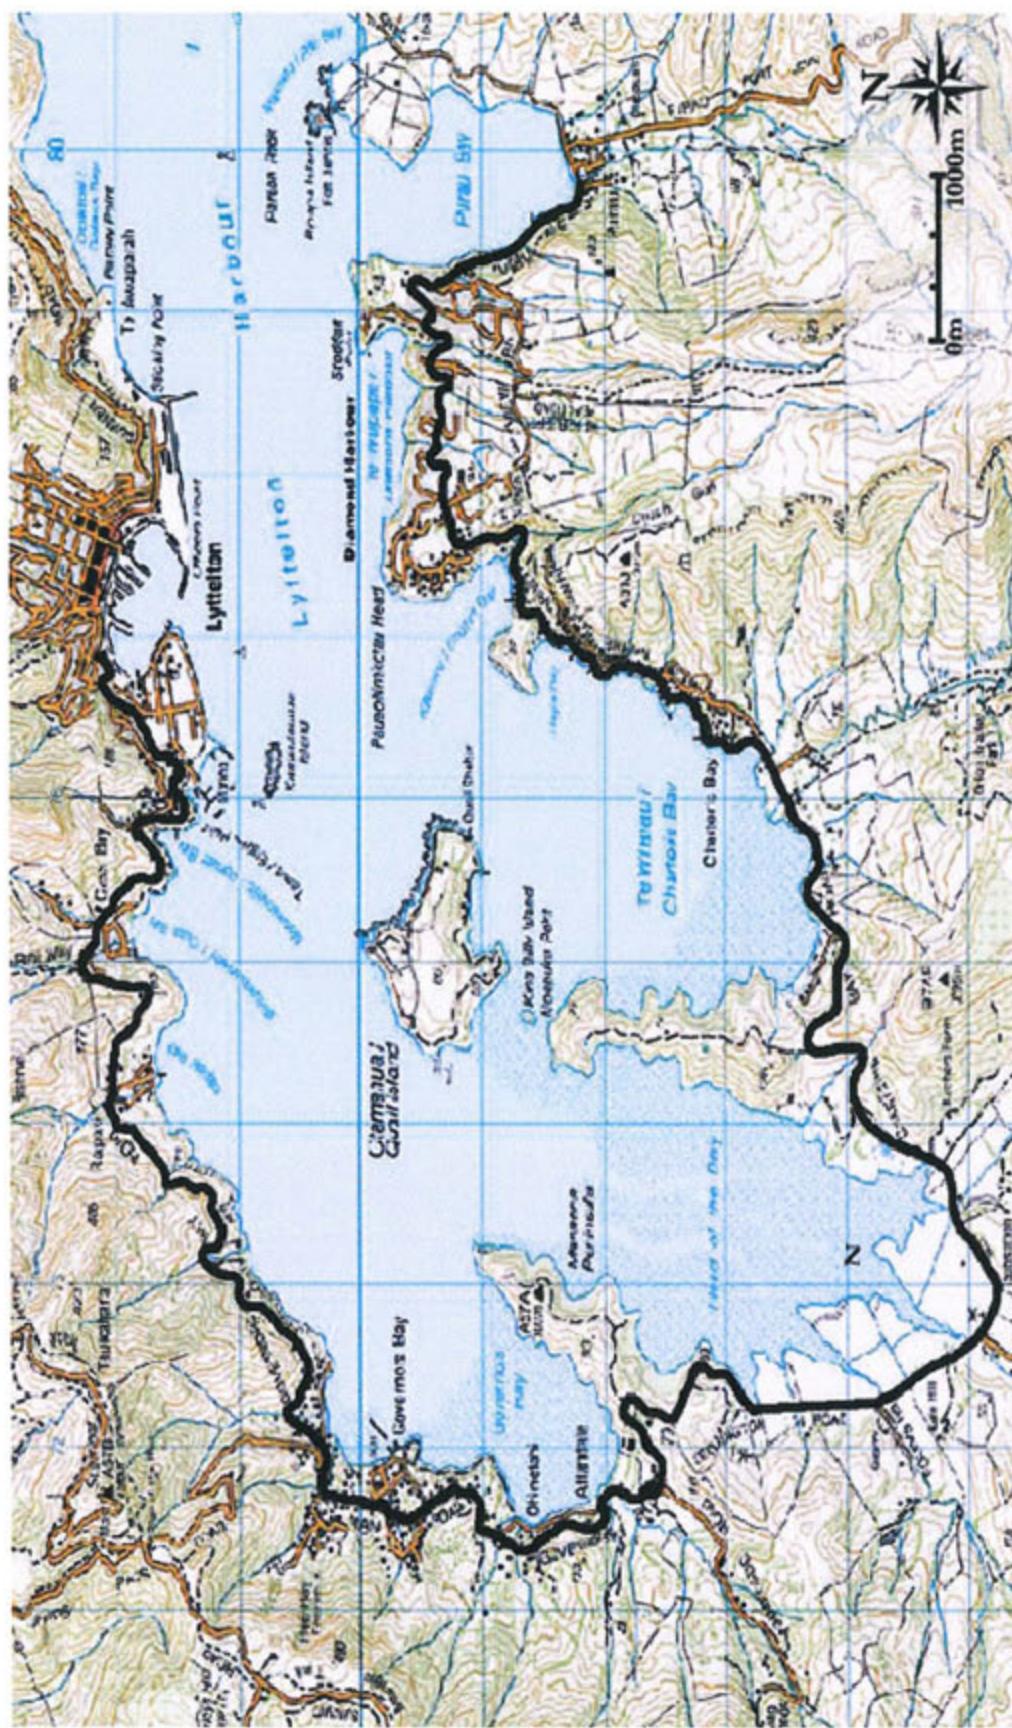
Figure 4.2.1: Map of Lyttelton Harbour showing State Highway 73 in black which is the focus area for this study (MeatMedia Limited 2010).

The key variables to sediment runoff from roadside cuttings were identified through relevant literature. The sites needing investigation on the main road (SH 74) around Lyttelton Harbour (Figure 4.2.1) were identified and the general lithologies of these road cuttings were obtained from the 'Lyttelton Harbour potential contamination source study 2007' (Environment Canterbury 2007) (Figure 3.1.1). Secondary rainfall data was obtained from NIWA (National Institute of Water and Atmospheric Research 2010). From this, any trends across the harbour were estimated.
